# MOISTURE ASSESSMENT REPORT

**123 Main St**

**Houston, TX 77001**

**Inspection Date: Today's Date**

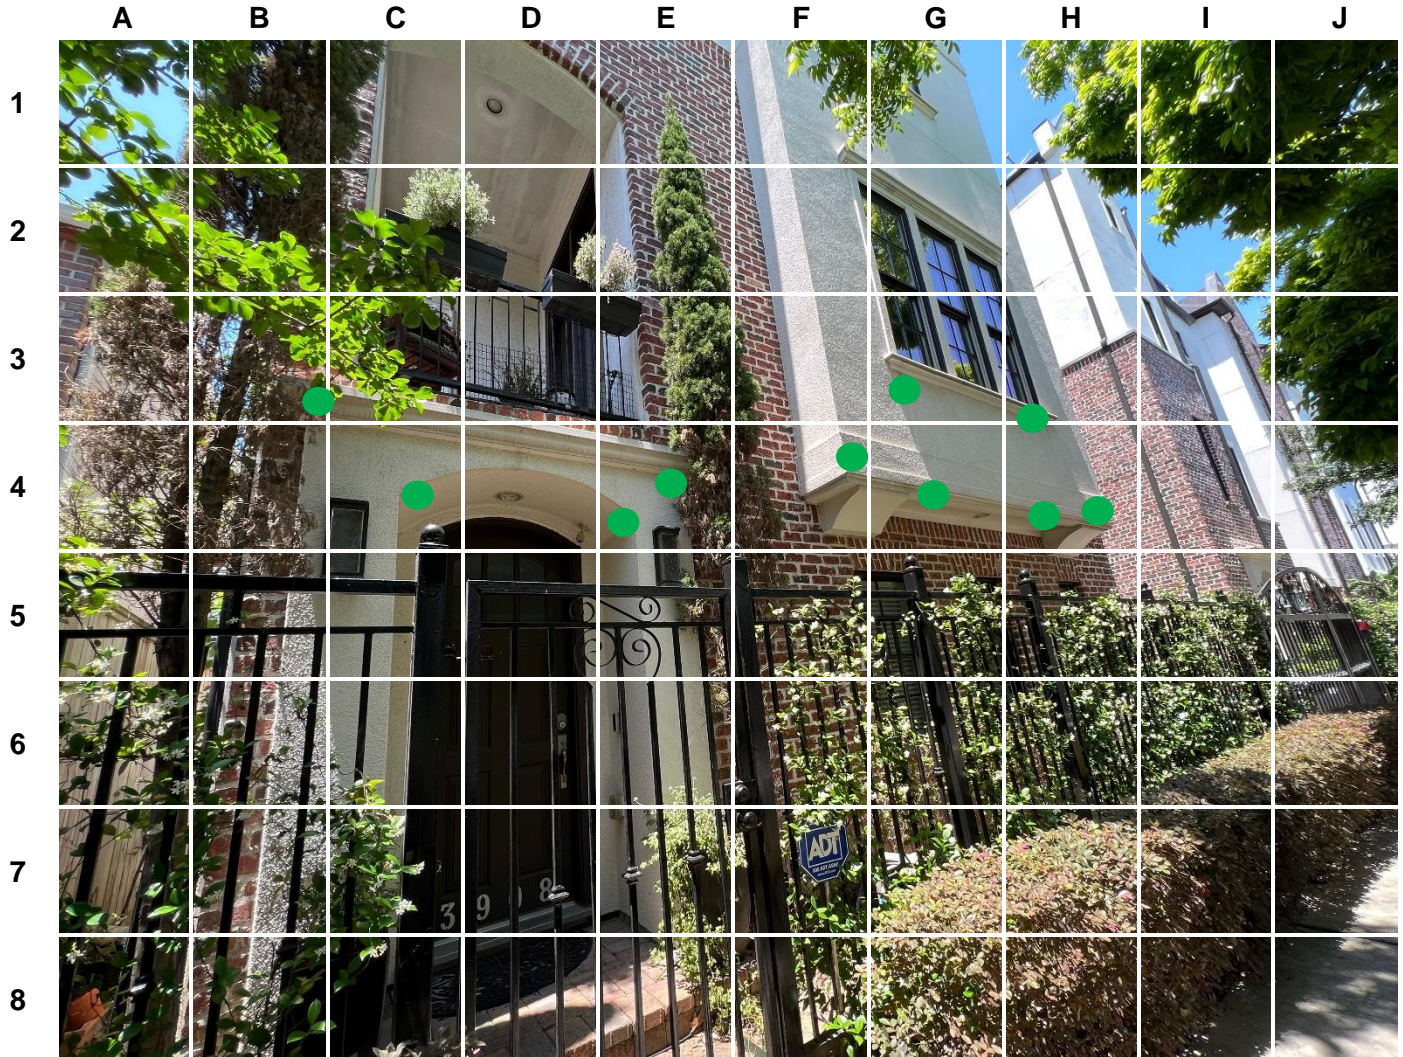
Photo 8.1

Grid	Description	%MC <sup>1</sup>	Moisture	Substrate	Observations
B3	Arch Face Left	18.5	MED	FIRM	
C4	Arch Soffit Left	8.1	LOW	FIRM	
E4 Left	Arch Soffit Right	15.8	MED	FIRM	
E4 Right	Arch Face Right	11.5	LOW	FIRM	
G3	Below Window Left	8.6	LOW	FIRM	
H3	Below Window Right	7.2	LOW	FIRM	
F4	Bumpout Wall Face (L)	6.1	LOW	FIRM	
H4 Right	Bumpout Wall Face (R)	8.2	LOW	FIRM	
G4	Weep Relief Opening (L)	16.3	MED	FIRM	
H4 Left	Weep Relief Opening (R)	11.3	LOW	FIRM

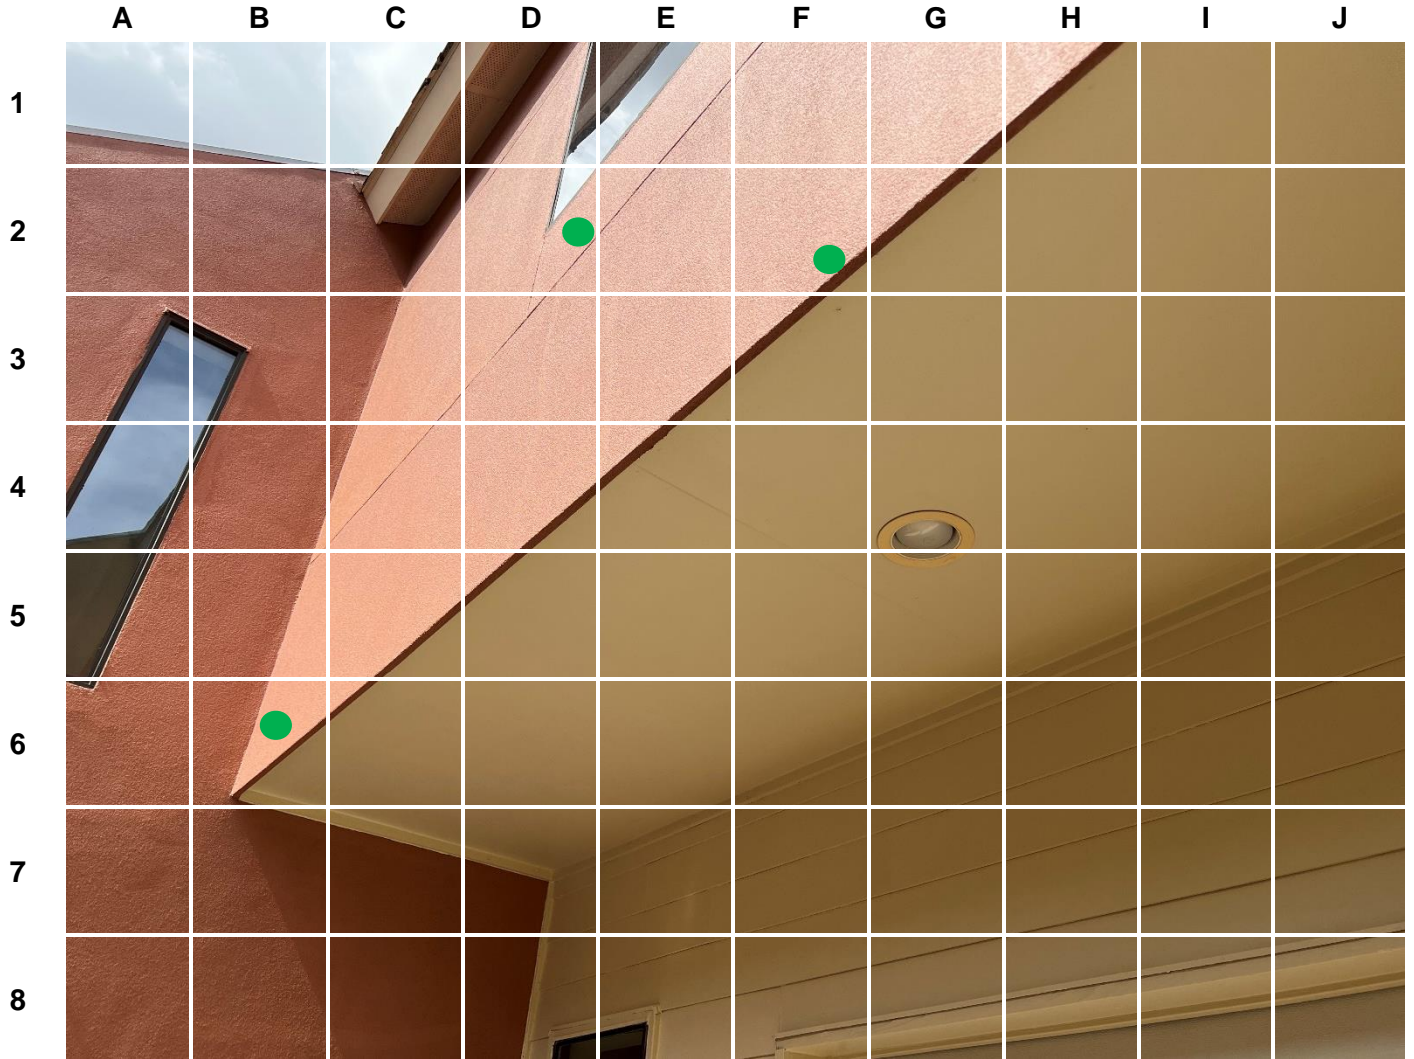
Photo 9.1

Grid	Description	%MC <sup>2</sup>	Moisture	Substrate	Observations
B6	Bumpout Wall	8.3	LOW	FIRM	
D2	Window Right	9.2	LOW	FIRM	
D5	Bumpout Wall	7.6	LOW	FIRM

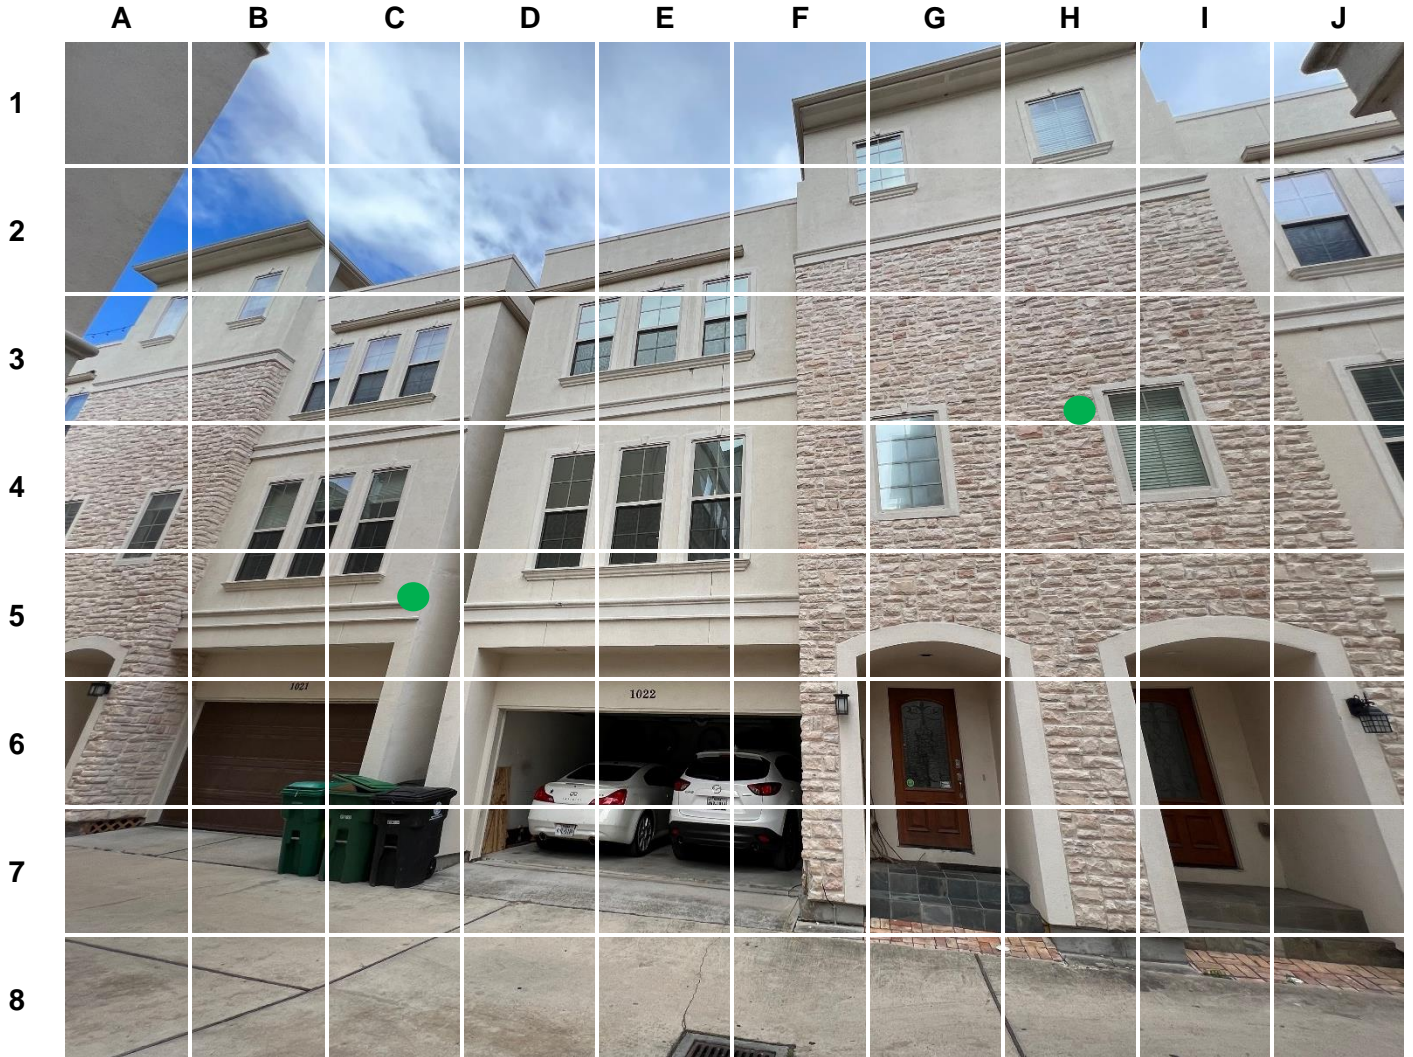
Photo 10.1

Grid	Description	%MC <sup>3</sup>	Moisture	Substrate	Observations
H3	Below Flat Detail	12.3	LOW	NONE	Reading believed to be taken in framing
C5	Below Roof/Stucco Intersection	20.3	LOW	NONE	Reading believed to be taken in framing
					Recommend core testing

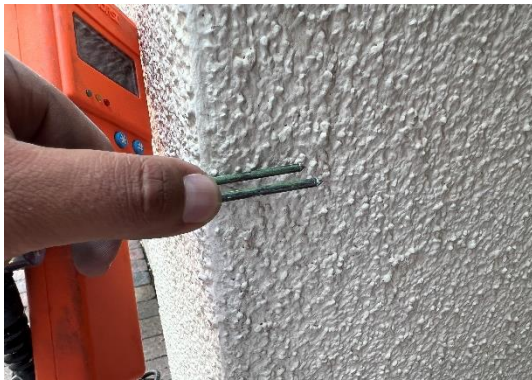
Upon inserting probe, the prongs extend well past the stucco and what would be the sheathing so likely extend into framing.

Photo 12.2 – prong extends past stucco and what would be the plywood

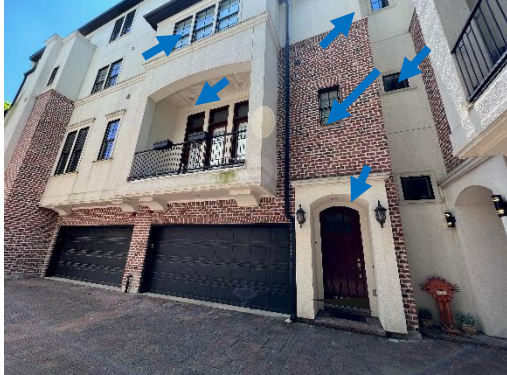
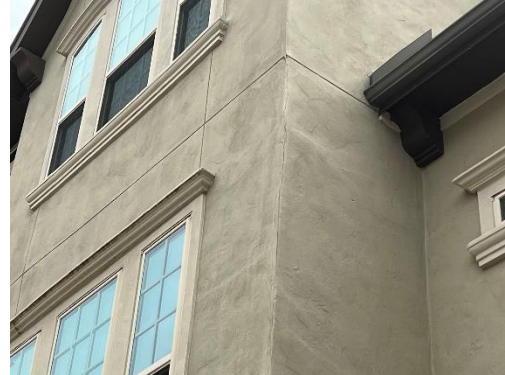
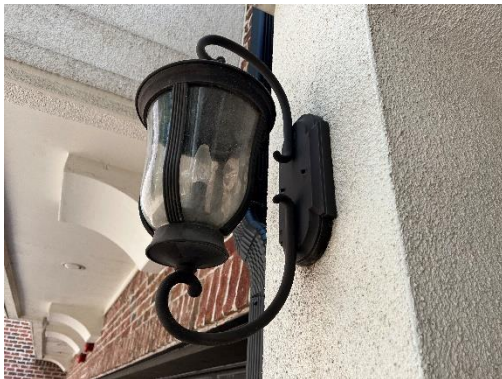
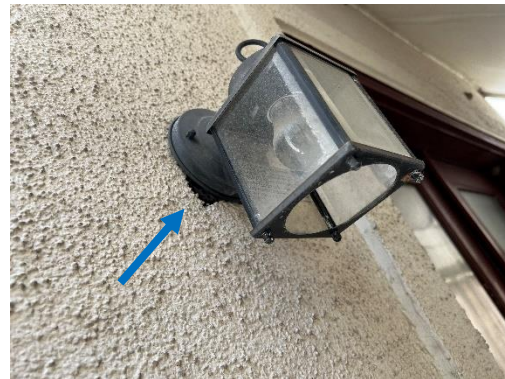
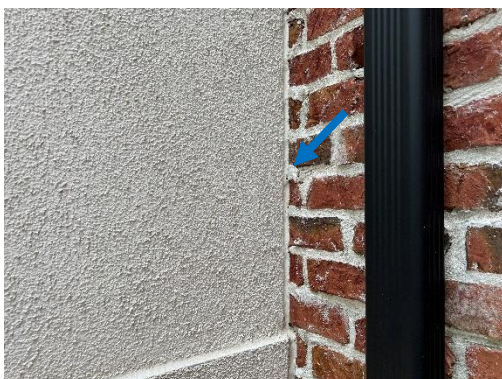
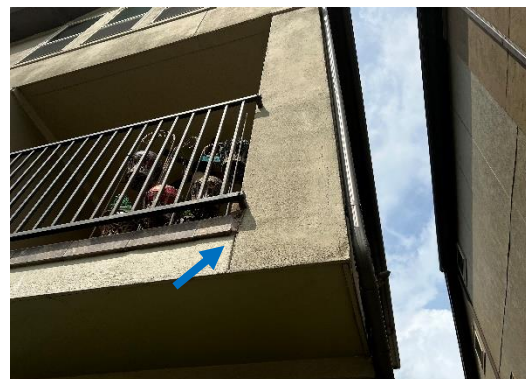
Rectify sealants throughout, penetrations, flashings, terminations, windows, door frames. Sealants appear to be of high quality but may have reached end of useful life. Recommend rectifying where needed.

Photo 13.1 - Windows

Photo 13.2

Photo 13.3 - Penetrations

Photo 13.4 - Seal hole

Photo 13.5 - Terminations

Photo 13.6 - Flashings

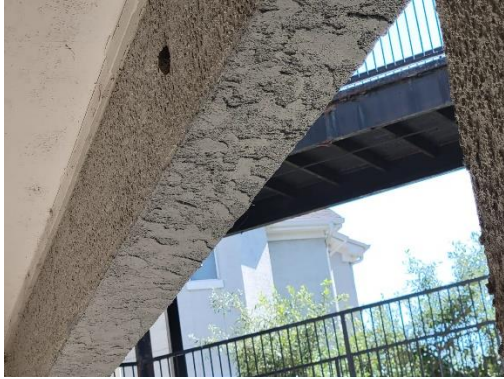
Photo 15.1

A weep relief drainage detail is present at some overhangs. It is sealed over in certain areas. Recommend removal of caulk at the wall/soffit intersection to allow drainage of water. Recommend install of weep relief at front entry and front 2<sup>nd</sup> story balcony if damage is present

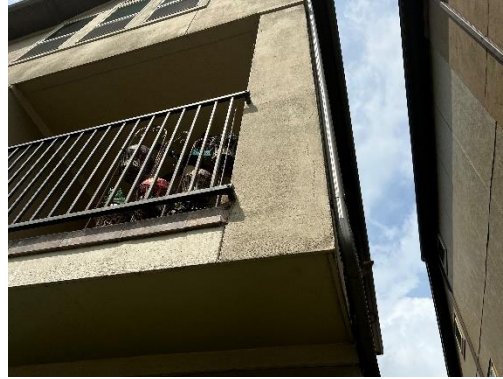
Photo 15.2 – recommend installation

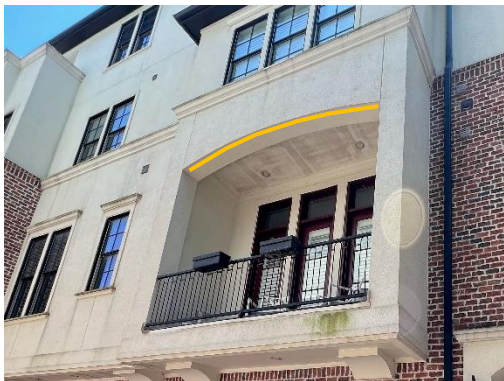
Photo 15.3 – recommend installation if damage found

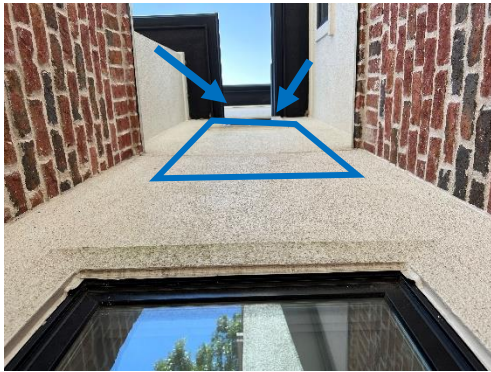
Kickout flashings not present at roof/stucco intersections. Unable to test moisture in area due to height. Recommend testing area in blue boxes when carrying out other stucco repairs.

Photo 16.4 – kickout flashing missing

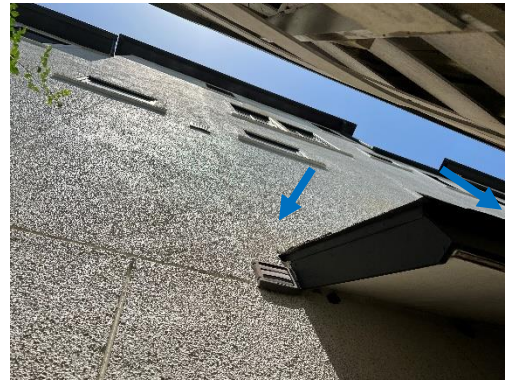
Photo 16.5 – This and other side as well

This area abuts with the neighbor's property and it may be on their side.

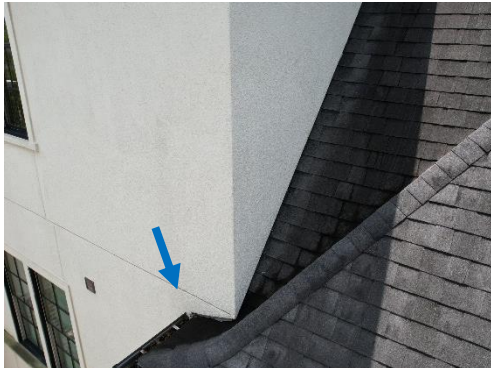
Photo 16.1 – kickout flashing missing

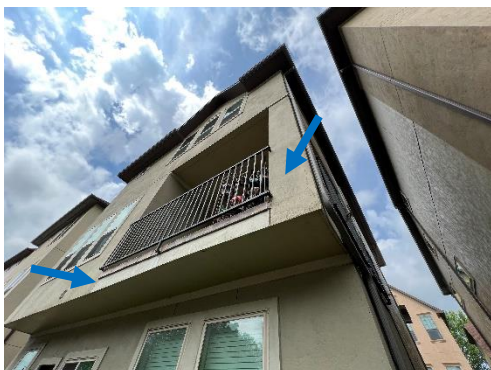
End dam flashings present at balcony sides. This is favorable. New standards recommend they extend 4" away from the wall. However no damage present at the wall when tested so no remedial repairs recommended at this time.

Photo 16.3 – end dam flashings present

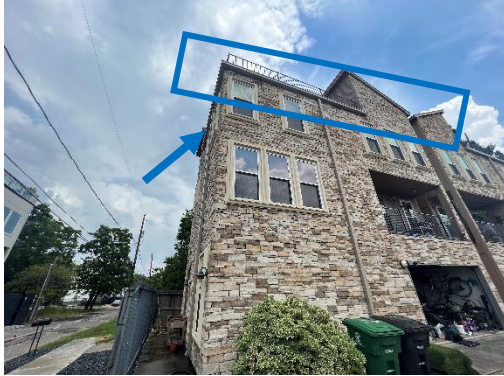
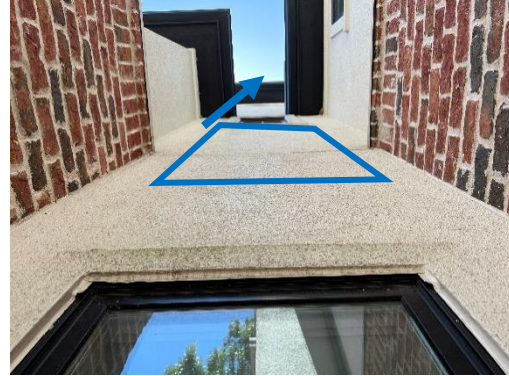
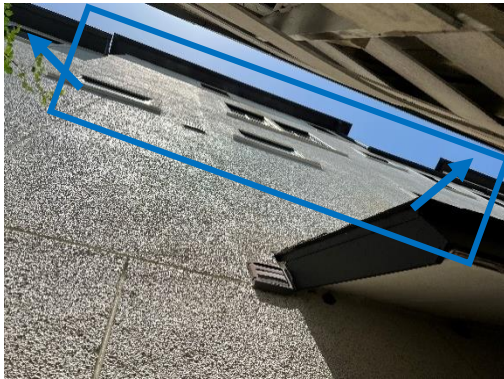
Front – 3<sup>rd</sup> Story & Above. & Rear Elevation – 3<sup>rd</sup> Story & Above

Photo 17.1 – Front Elevation

Photo 17.3 – Rear Elevation

The following areas were unreachable by ladder, recommend probing or further investigation when doing any other repairs with scaffolding or other equipment.

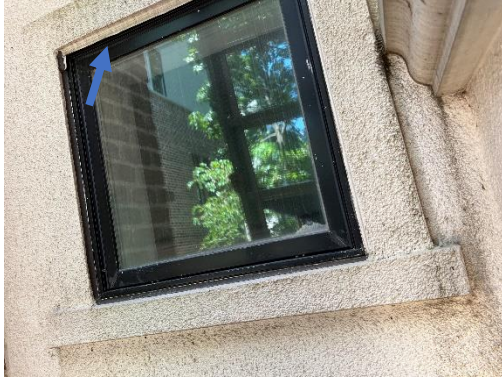
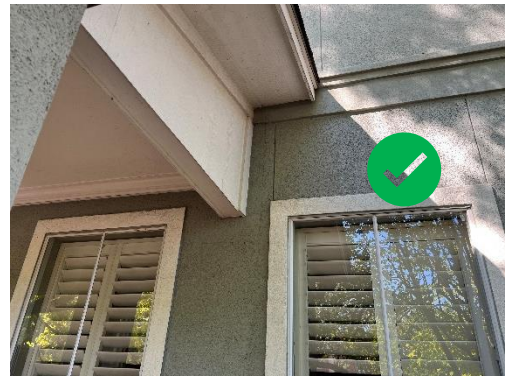
Head flashing present at windows. This is favorable.

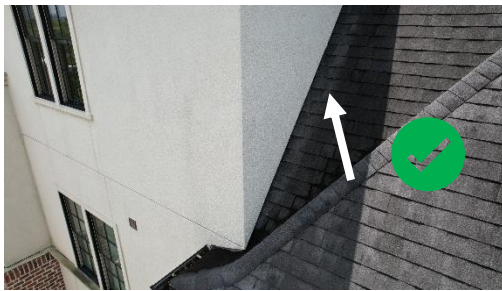
Photo 18.3

Clearance of is present between stucco and roofing. Not a full 2" but would consider favorable unless other damages or leaks start to appear.

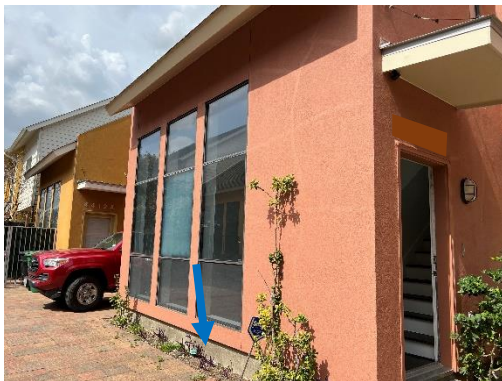
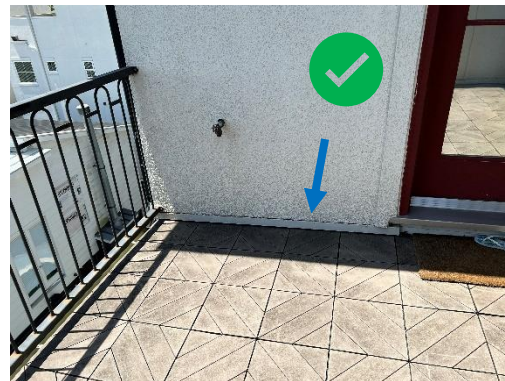
Clearance of 2" clearance required at stucco/flatwork intersection. Not a full 2" at entry but would consider functional unless other damages or leaks start to appear. Terrace appears to have counterflashing in addition to clearance.

Photo 18.4 - balconies

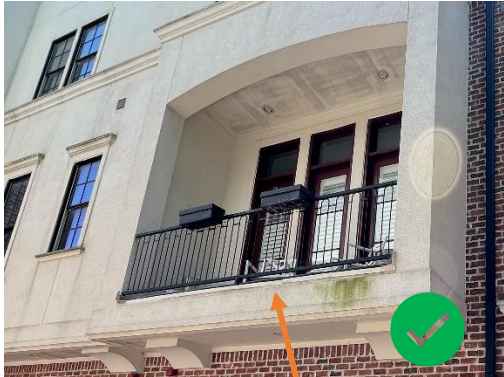
Photo 19.4

Drip edge flashings present. This is favorable.

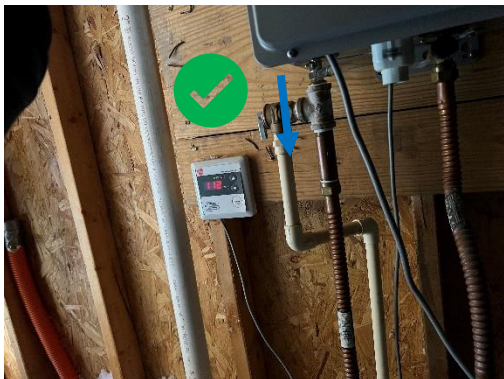
Photo 19.1

No damage found inside attic with exterior stucco wall.
